RECORD OF DEFECTS ARISING IN MAJOR WORKS

Recorded by Leaseholders in
Brighton and Hove City Council Property

Carried out under the Term Contract with Messrs. Mears
between 2010 and 2020

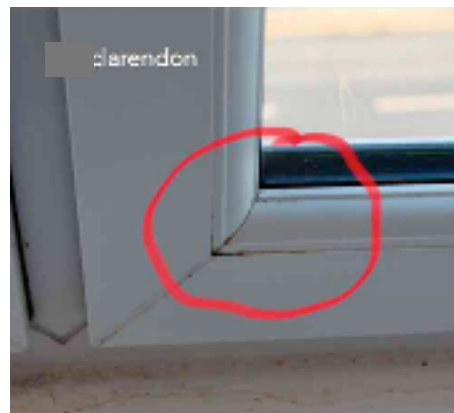
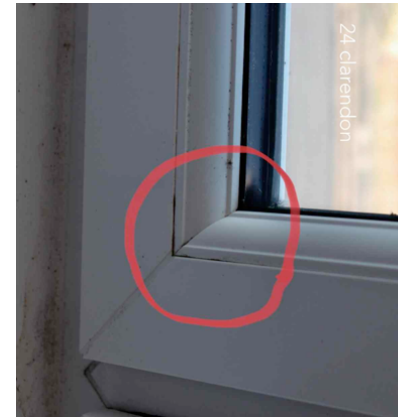
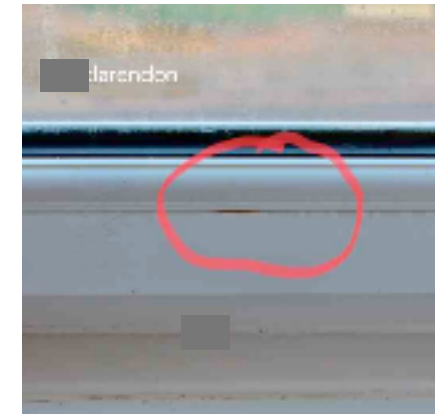
Top row:
Shows water has seeped out past the glass and started to form black mould

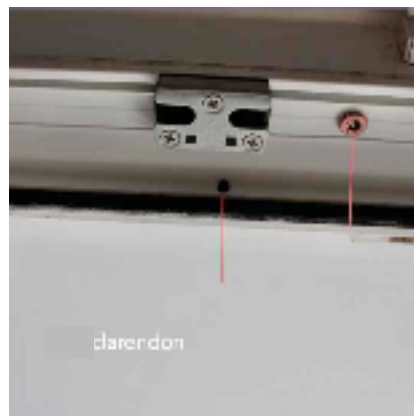
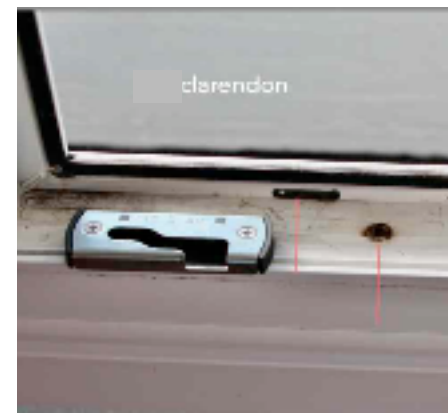
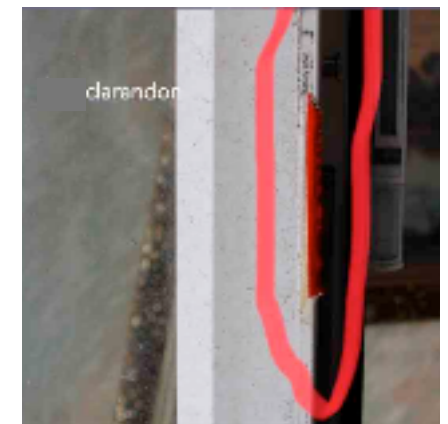
Bottom row:
Drain holes not appropriate for inward opening windows, and which are allowing the water to run round the frame and into the flat. Also none of the screws are sealed.

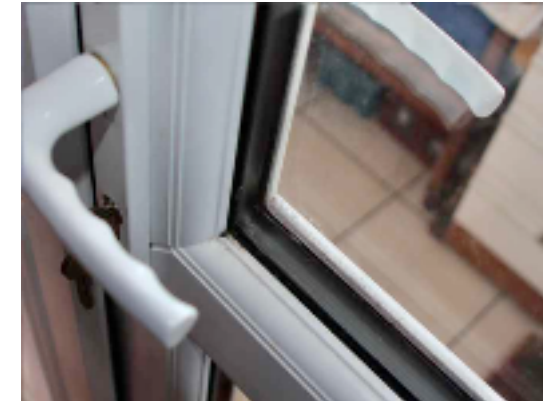
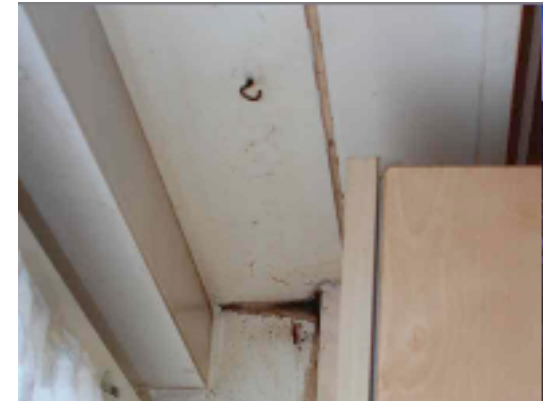
Top two rows are from a tenants flat next to the north lift top floor. More of the same problems.

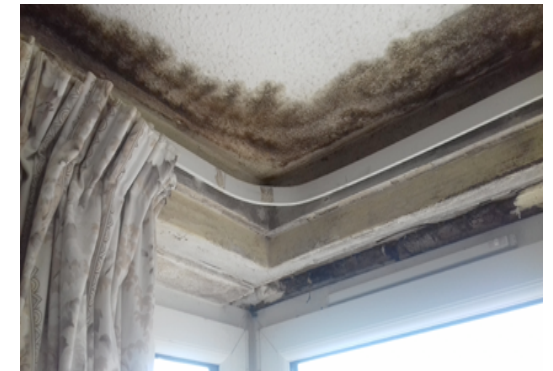
Photos showing severe damp over head of windows

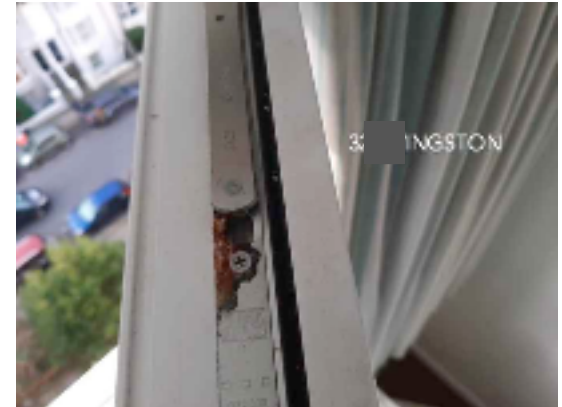
Centre left: windows are running out by 12mm and covering the drip channel
Centre right: corrosion of ironmongery in window head due to leaking.

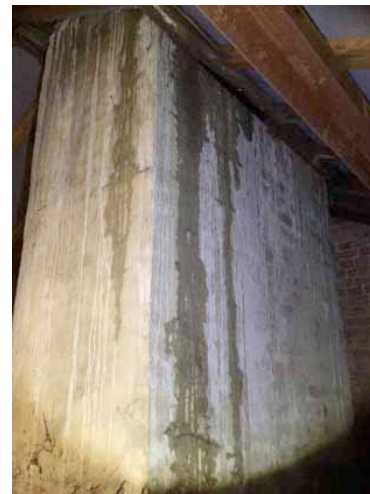
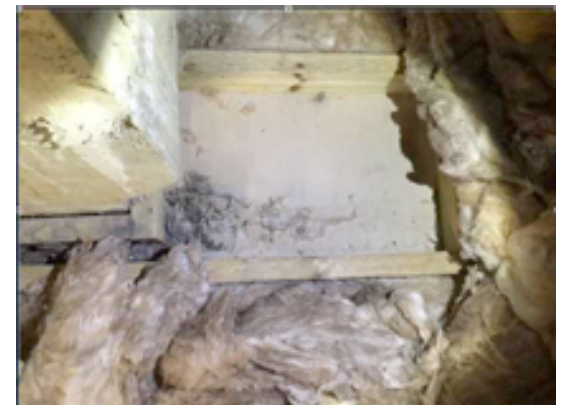
- leak on the chimney stack still outstanding - water coming through onto lounge ceiling, a faint watermark along a joint line 40cm from the chimney face and evidence of water on the back of the plasterboard

- insufficient flashing on chimney, gaping lead flashings and some old and missing pointing (pictures attached)
- the north chimney flashing is now leaking on three sides.

Top: leaking affecting adjacent ceiling as evident in roof void
Centre: general external view of chimney
Bottom: details of flashing

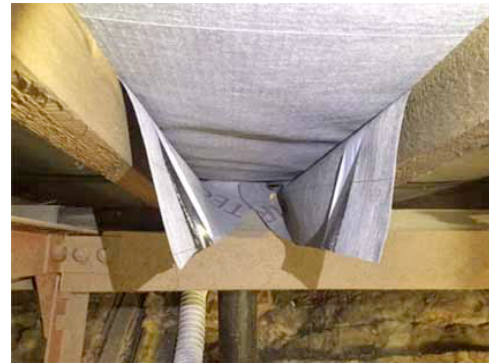
Left: gaps in poorly laid sarking felt

Right: drooping in poorly laid sarking felt

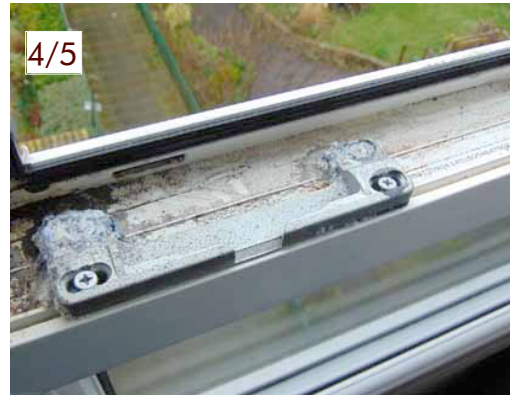
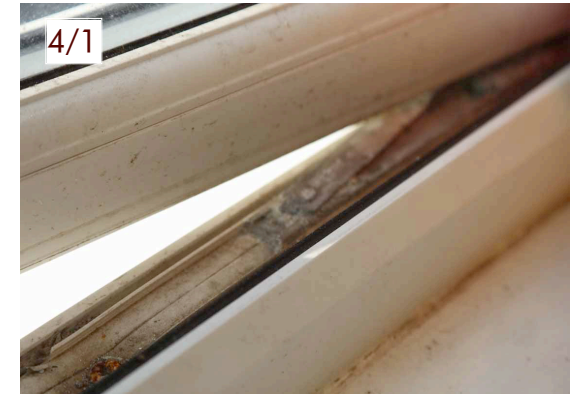
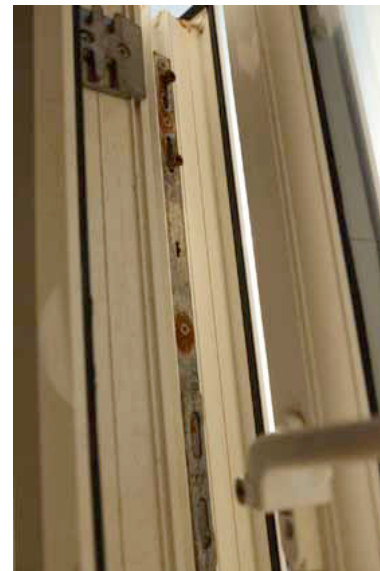
Defective ironmongery including corrosion, mortar spills etc.

4/5: corrosion and mortar spills affecting operation of lock

4/1: corrosion of stays

1/2: corrosion of sliding locking bolt.

4/6: mortar spills affecting operation of lock

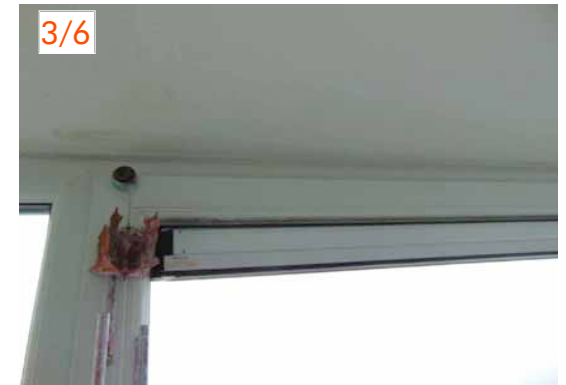
3/4: Leaking at head of window and jamb

3/7: Dislodged gasket internally

3/6: Defective installation of blind

3/7: Mortar stains on glass, labels not removed
