RECORD OF DEFECTS ARISING IN MAJOR WORKS

Recorded by Leaseholders in  
Brighton and Hove City Council Property

Carried out under the Term Contract with Messrs. Mears  
between 2010 and 2020

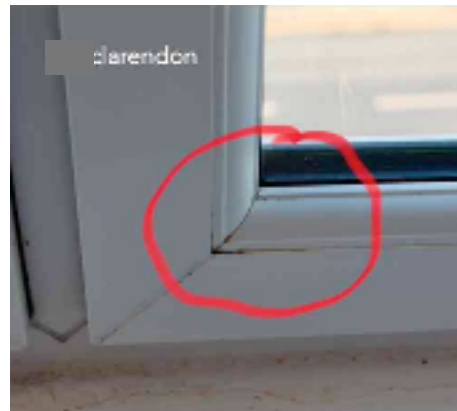
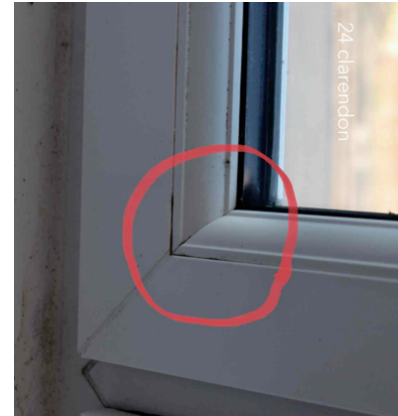
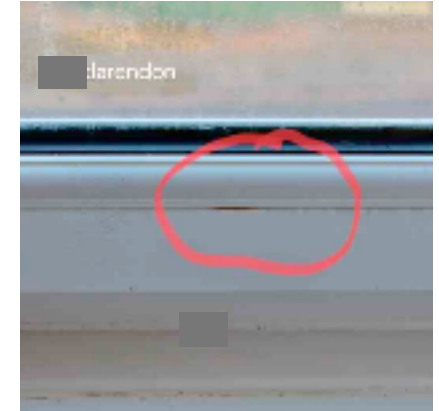
Top row:  
Shows water has seeped out past the glass and started to form black mould

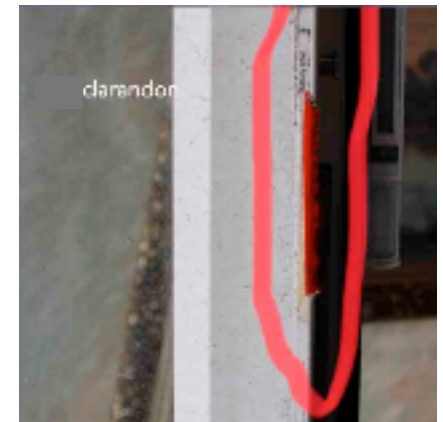
Bottom row:  
Drain holes not appropriate for inward opening windows, and which are allowing the water to run round the frame and into the flat. Also none of the screws are sealed.

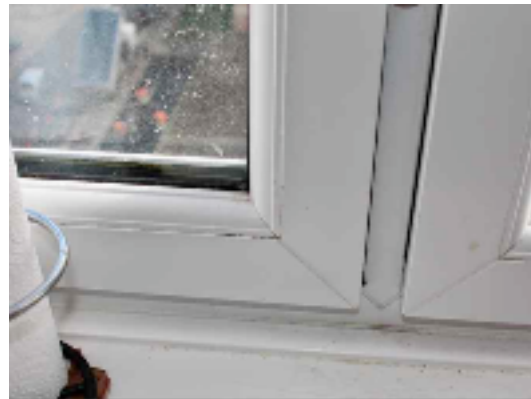
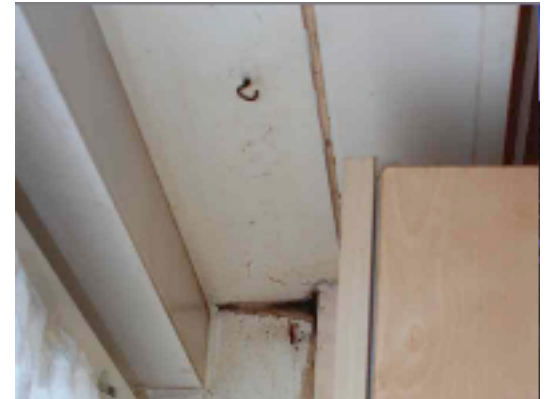
Top two rows are from a tenants flat next to the north lift top floor. More of the same problems.

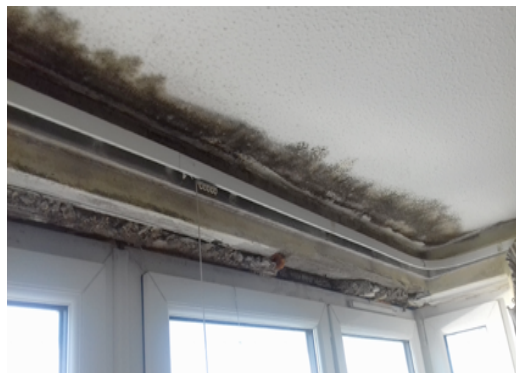
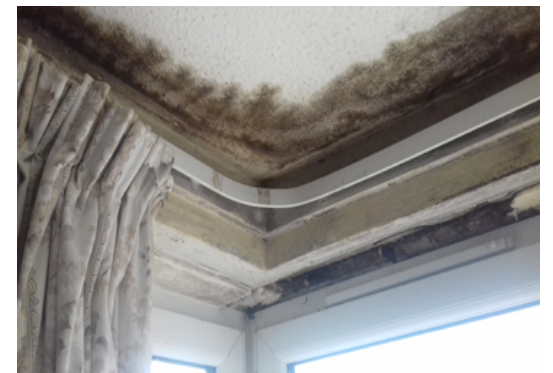
Photos showing severe damp over head of windows

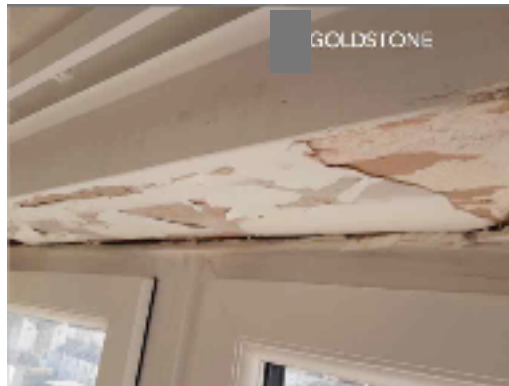
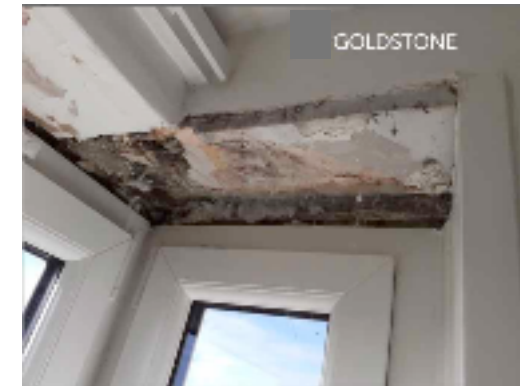
Centre row:  
Damage due to defective installation and work over window heads including missing and displaced foam filler, and disruption of finishes from water penetration through oversized joint. Possibly reveals lack or external weatherseal at head.

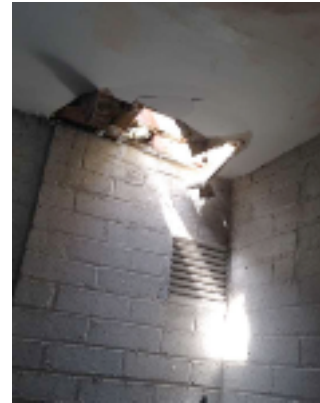
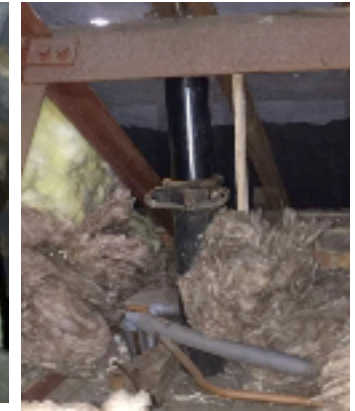
The Willows: Examples of defects  
 Top: ceiling damaged by roofer  
 Visible gap in chimney flashing  
 Vent pipe replaced where penetrating roof but existing hole not repaired  
 Centre: poor workmanship:  
 sundry leaks, incomplete lining to roof  
 Bottom: leaking replacement downpipes, possibly undersized, and displaced leak guard  
 Unfixed and poorly installed soffit

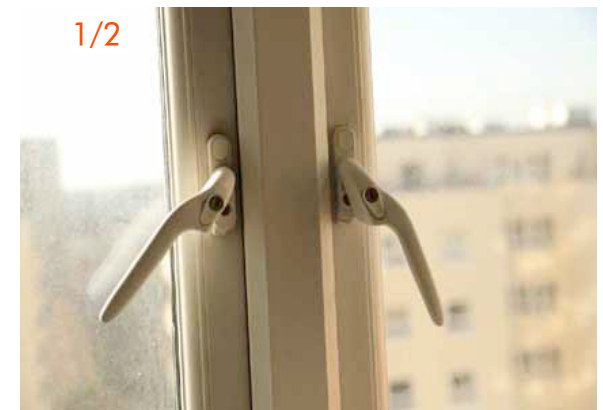
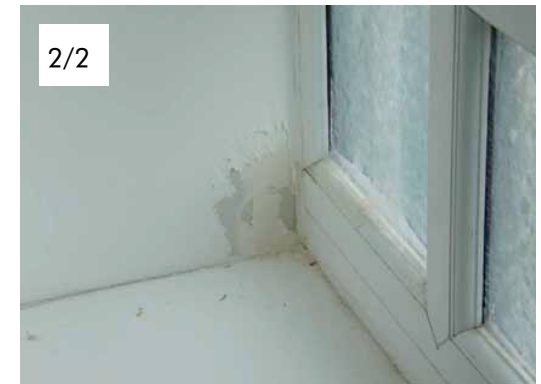
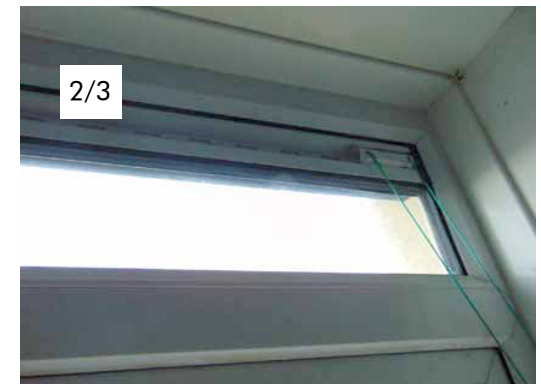
1/1: Malfunctioning restrictors

1/2 Latches not fully closing

2/1 Condensation or damp penetration

2/2 Water ingress due to faulty seal

2/3 Inaccessible fan control, affecting ventilation and encouraging condensation.

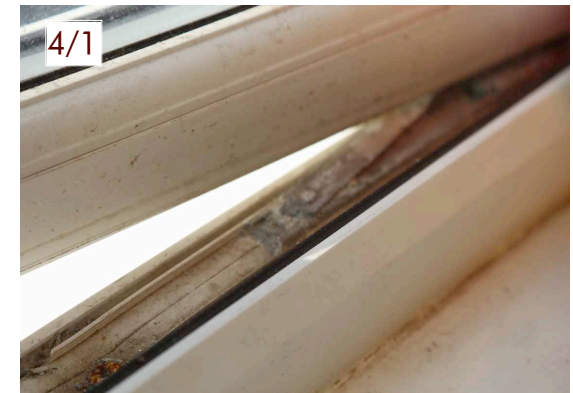
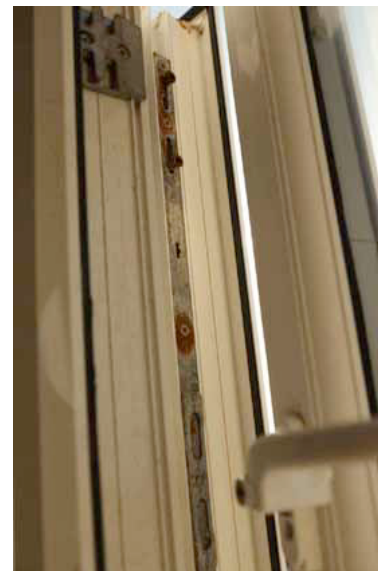
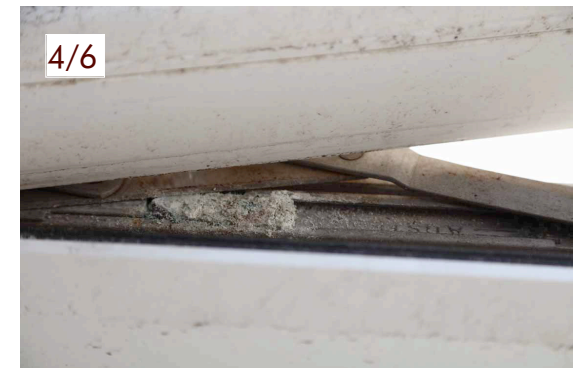
Defective ironmongery including corrosion, mortar spills etc.

4/5: corrosion and mortar spills affecting operation of lock

4/1: corrosion of stays

1/2: corrosion of sliding locking bolt.

4/6: mortar spills affecting operation of lock

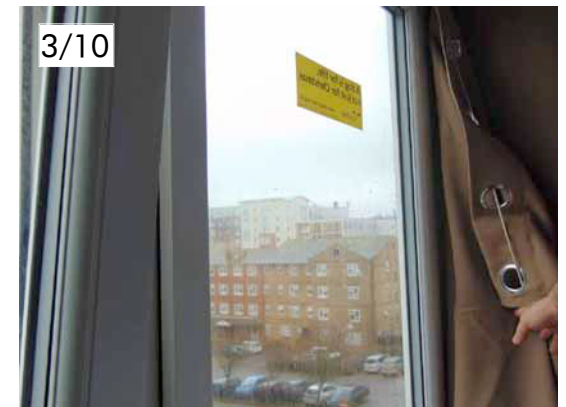
3/4: Leaking at head of window and jamb

3/7: Dislodged gasket internally

3/6: Defective installation of blind

3/7: Mortar stains on glass, labels not removed
