RECORD OF DEFECTS ARISING IN MAJOR WORKS

Recorded by Leaseholders in  
Brighton and Hove City Council Property

Carried out under the Term Contract with Messrs. Mears  
between 2010 and 2020

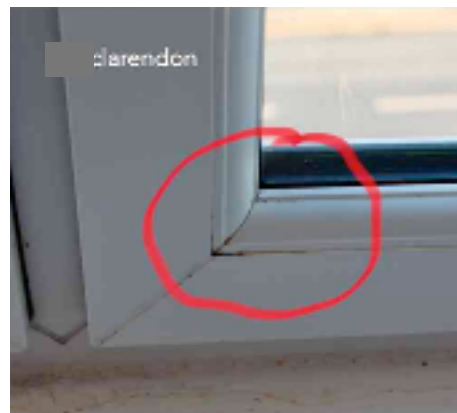
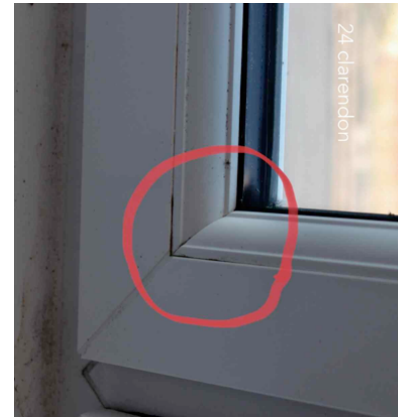
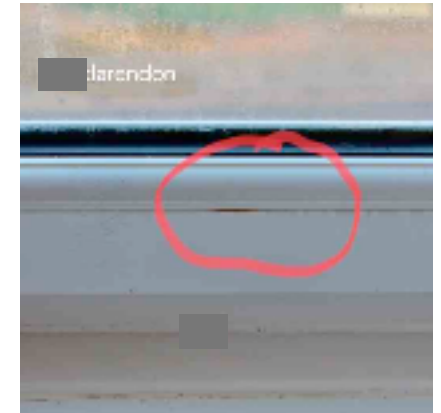
Top row:  
Shows water has seeped out past the glass and started to form black mould

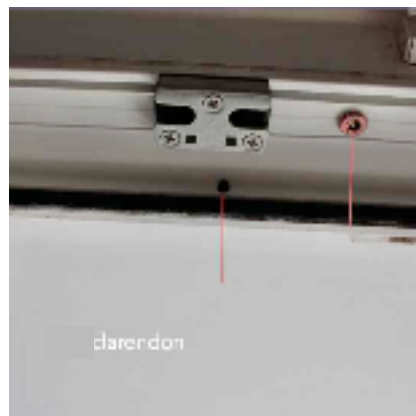
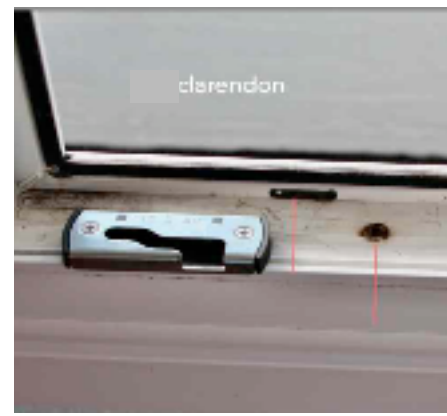
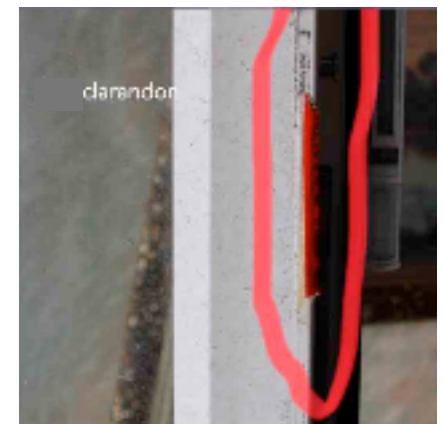
Bottom row:  
Drain holes not appropriate for inward opening windows, and which are allowing the water to run round the frame and into the flat. Also none of the screws are sealed.

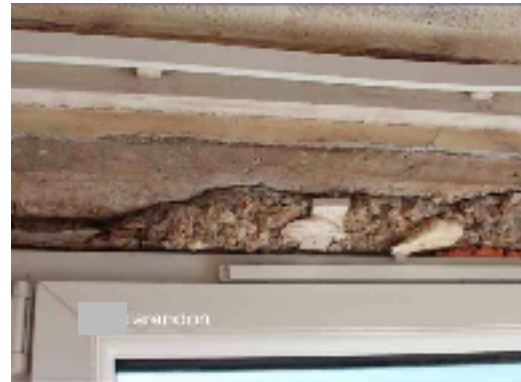
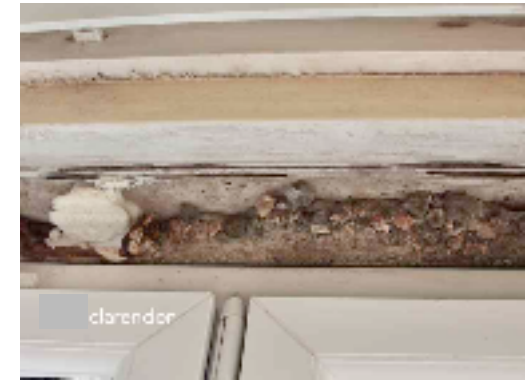
Top row:  
Show the windows have not been installed correctly. Water has been flowing into these joints and across the ceiling .

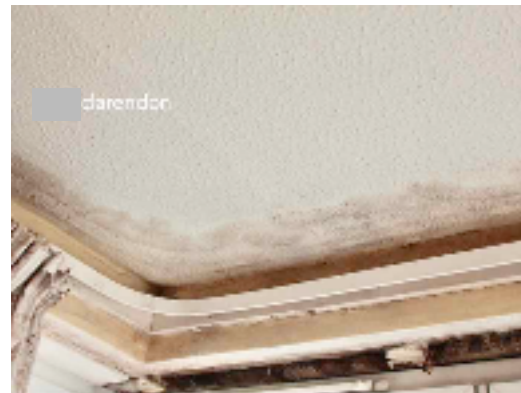
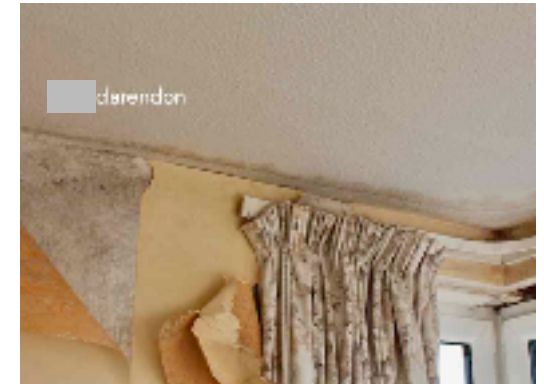
Centre row:  
Show the windows have not been installed correctly. Water has been flowing into these joints and across the ceiling .

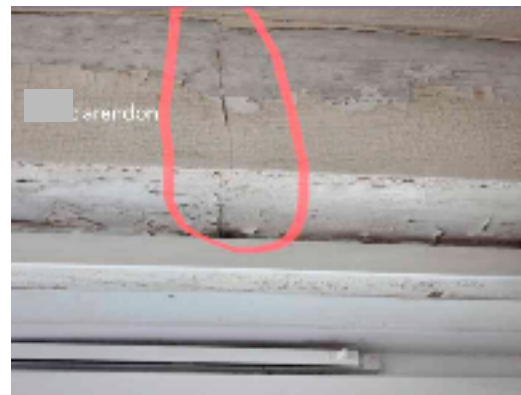
Bottom left:: unidentified: crack in concrete repair over window head

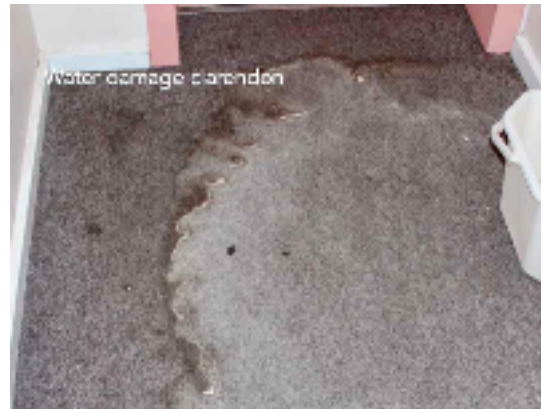
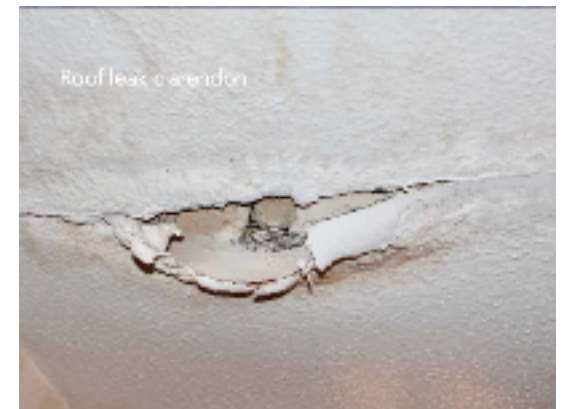
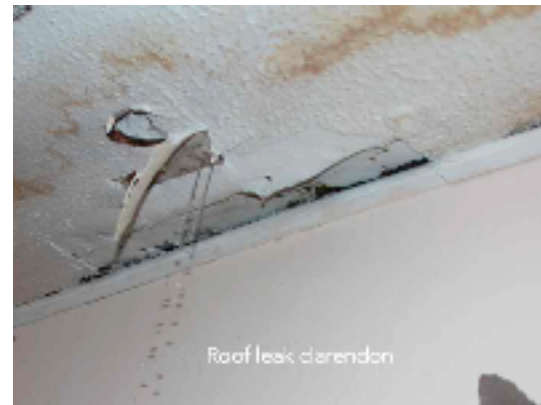
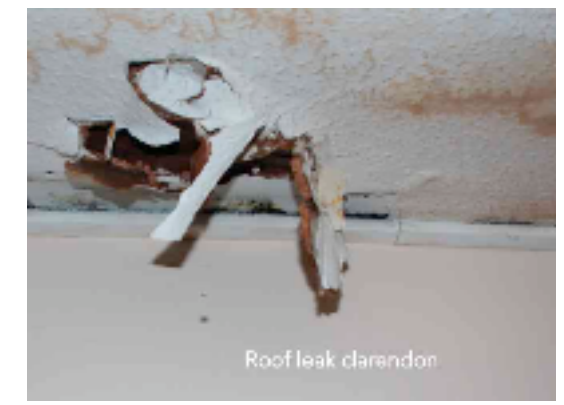
Top and centre rows:  
Shows water damage from the new roof and  
lift motor room

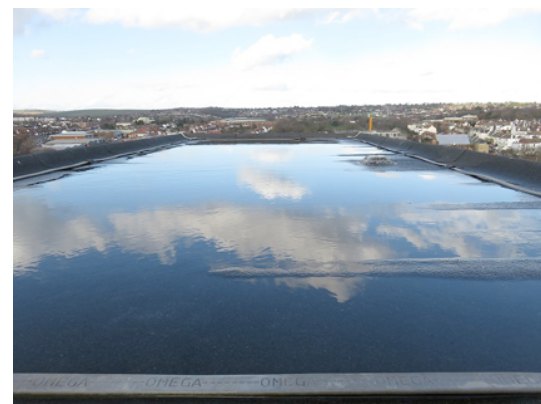
Bottom left: new lift motor room roof as  
installed showing raised r/w outlet causing  
flooding of roof.

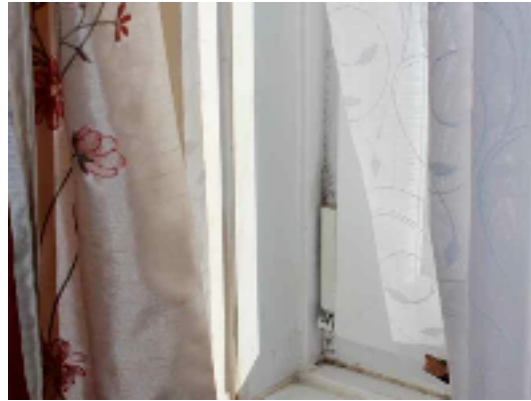
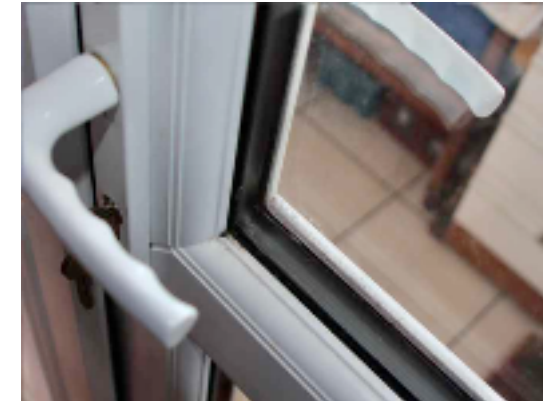
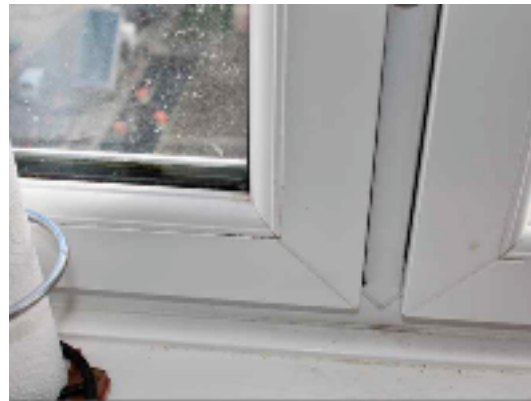
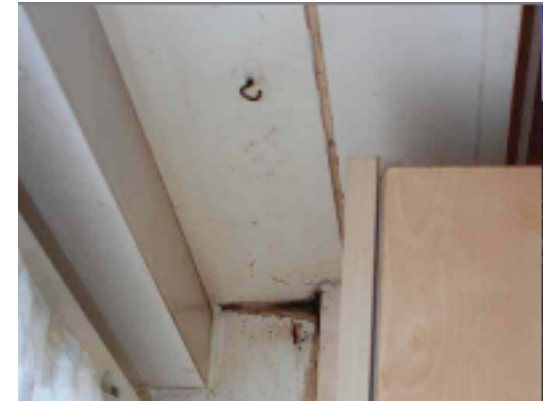
Top two rows are from a tenants flat next to the north lift top floor. More of the same problems.

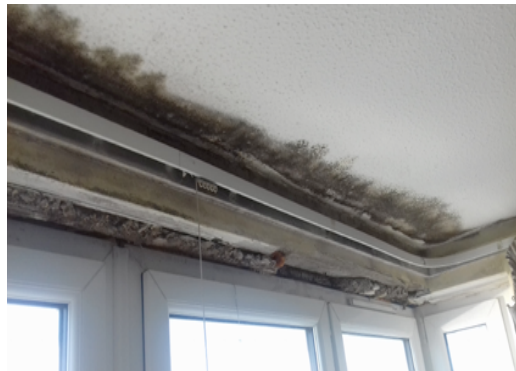
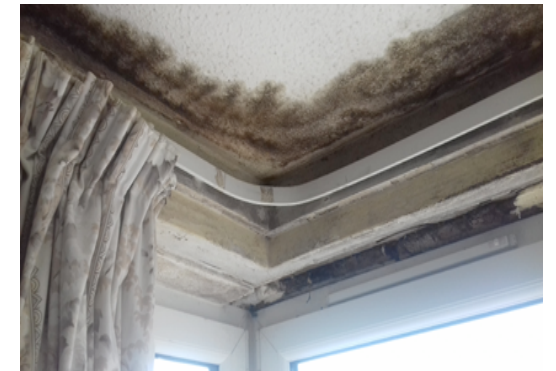
Photos showing severe damp over head of windows

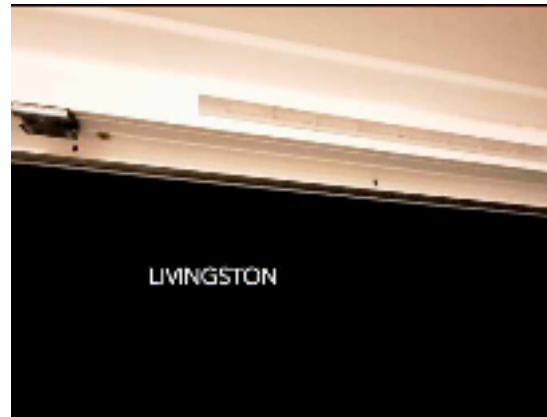
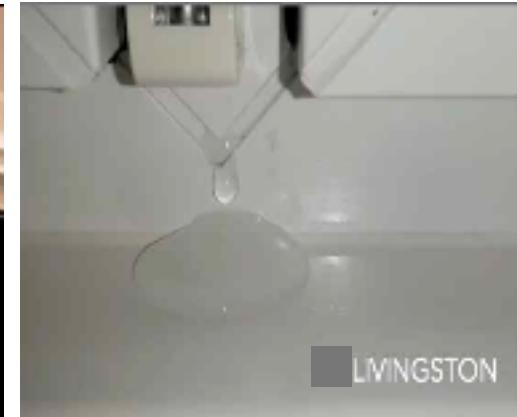
Top row:  
Water pathway showing what happens when it rains.  
Rh photo shows leaking through screw holes

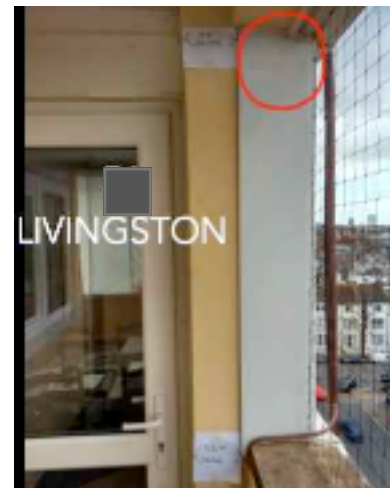
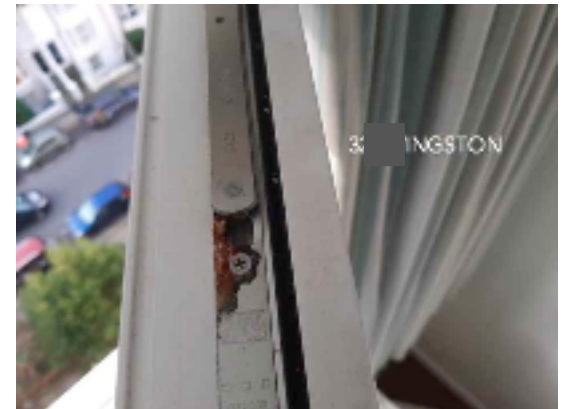
Centre left: windows are running out by 12mm and covering the drip channel  
Centre right: corrosion of ironmongery in window head due to leaking.

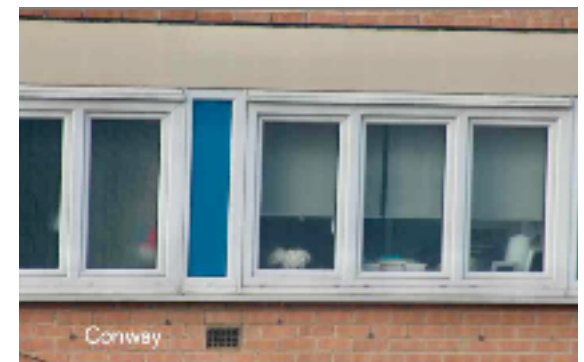
Bottom right:  
The windows at the back have what appears to be a drip strip above them. The rest of the block does not have this since the original drips were removed or covered over during the major works. These may have been put in to rectify the damage, but not applied on the rest of the block.

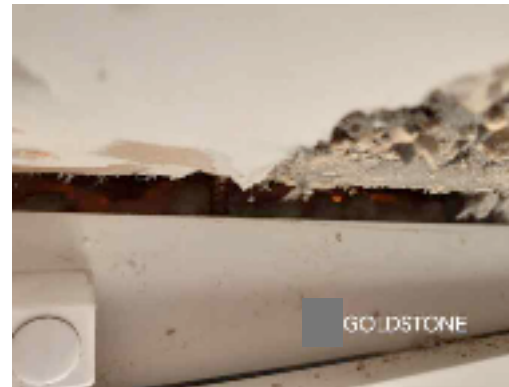
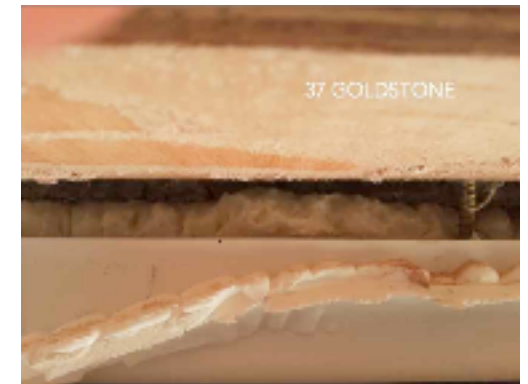
Top row:  
Defective work over window heads including missing and displaced foam filler, and disruption of finishes from water penetration through oversized joint. Reveals lack of external weatherseal at head.

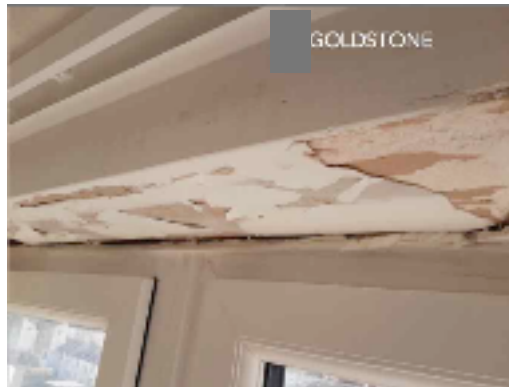
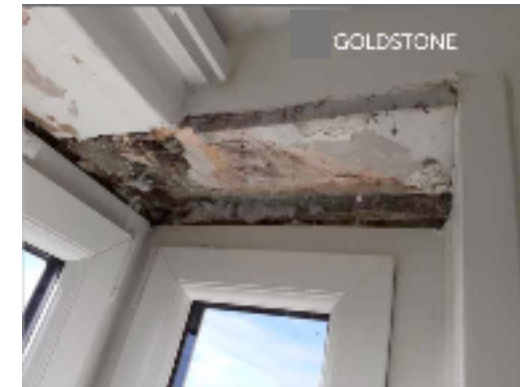
Centre row:  
Damage due to defective installation and work over window heads including missing and displaced foam filler, and disruption of finishes from water penetration through oversized joint. Possibly reveals lack of external weatherseal at head.

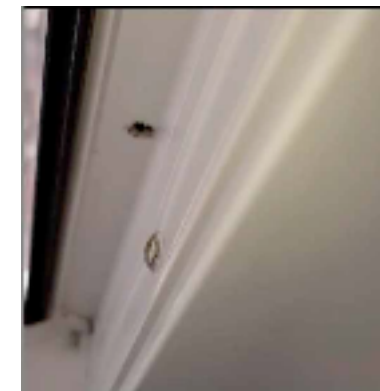
Bottom right:  
Shows water running out of screw hole

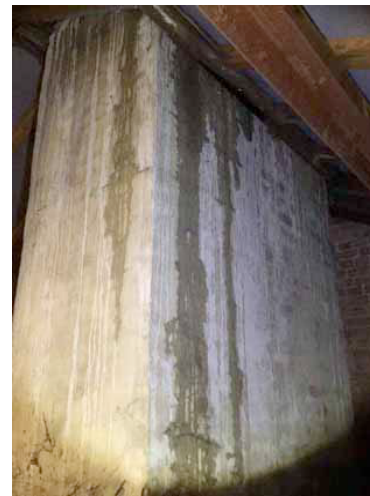
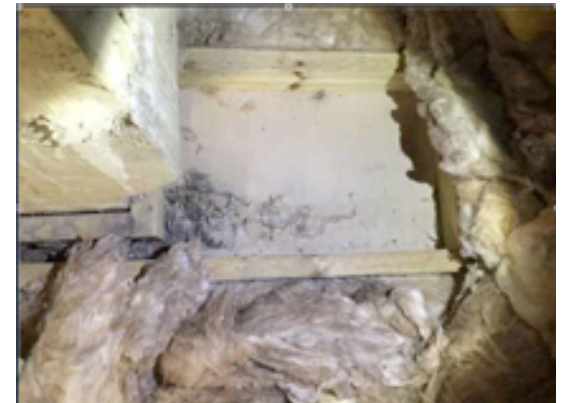
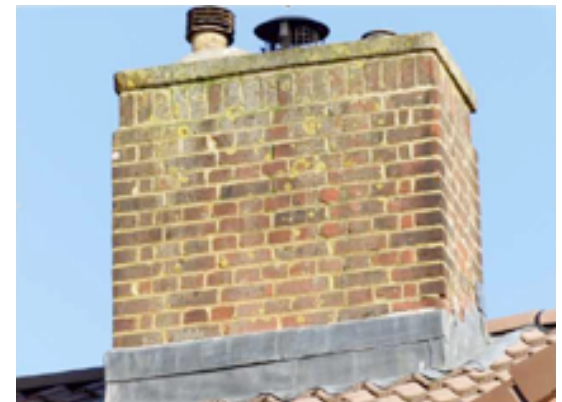
- leak on the chimney stack still outstanding - water coming through onto lounge ceiling, a faint watermark along a joint line 40cm from the chimney face and evidence of water on the back of the plasterboard

- insufficient flashing on chimney, gaping lead flashings and some old and missing pointing (pictures attached)
- the north chimney flashing is now leaking on three sides.

Top: leaking affecting adjacent ceiling as evident in roof void  
Centre: general external view of chimney  
Bottom: details of flashing

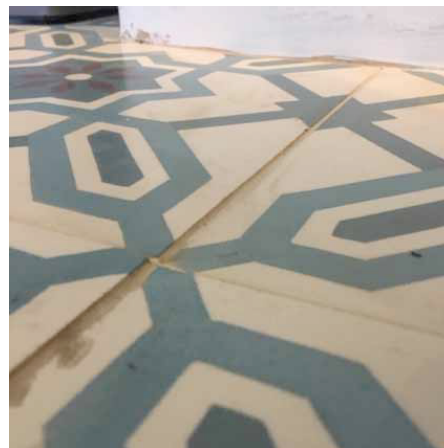
Bottom: damage to internal floor finish from leak following roofing works.

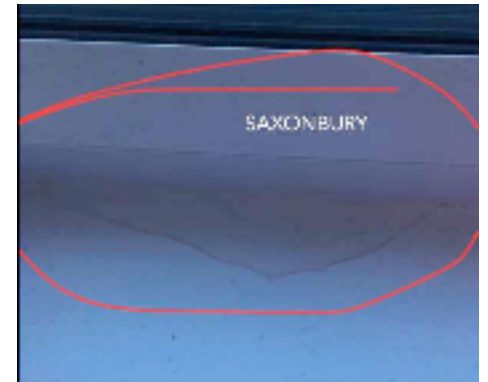
Slide 33 Saxonbury: shows damp or condensation at high level on external wall at high level..

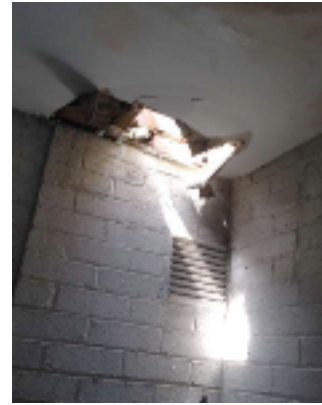
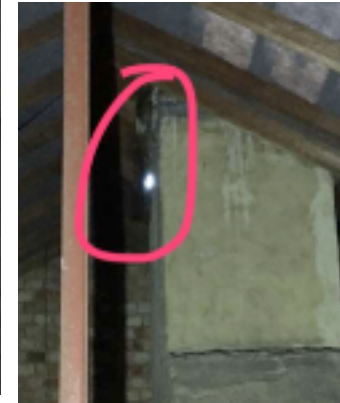
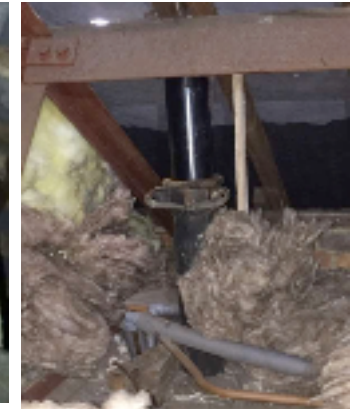
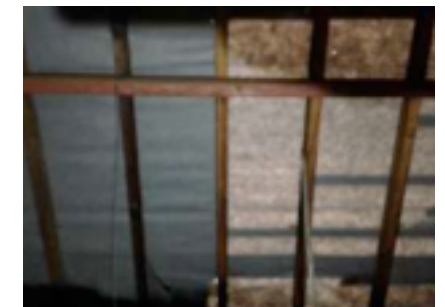
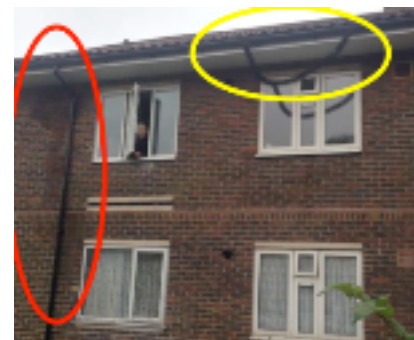
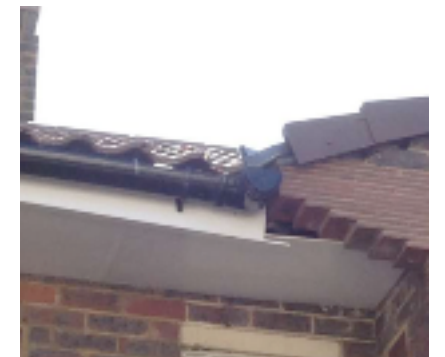
The Willows: Examples of defects  
 Top: ceiling damaged by roofer  
 Visible gap in chimney flashing  
 Vent pipe replaced where penetrating roof but existing hole not repaired  
 Centre: poor workmanship: sundry leaks, incomplete lining to roof  
 Bottom: leaking replacement downpipes, possibly undersized, and displaced leak guard  
 Unfixed and poorly installed soffit

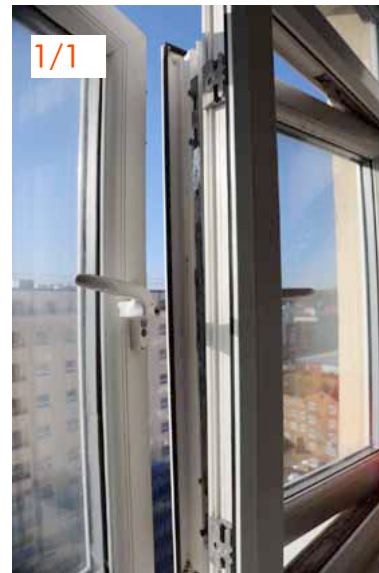
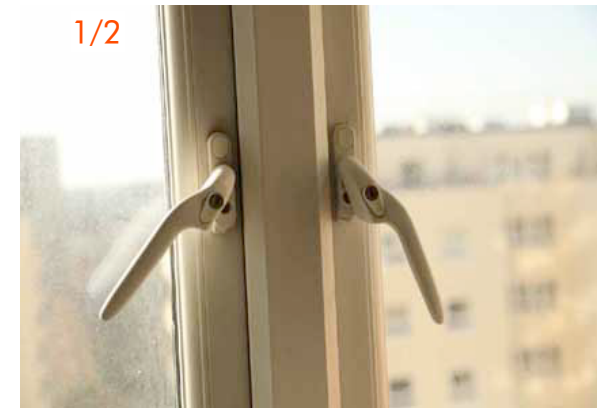
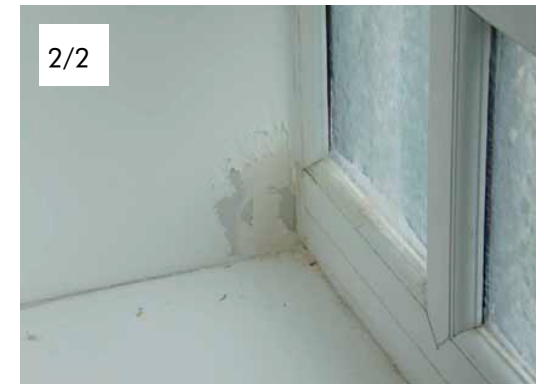
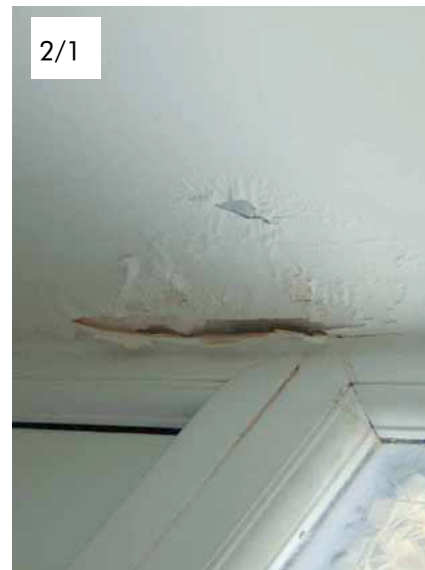
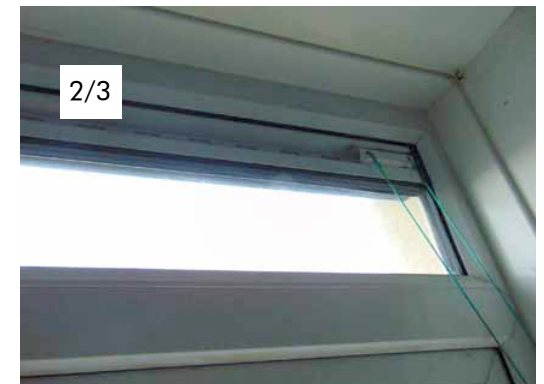
1/1: Malfunctioning restrictors

1/2 Latches not fully closing

2/1 Condensation or damp penetration

2/2 Water ingress due to faulty seal

2/3 Inaccessible fan control, affecting ventilation and encouraging condensation.

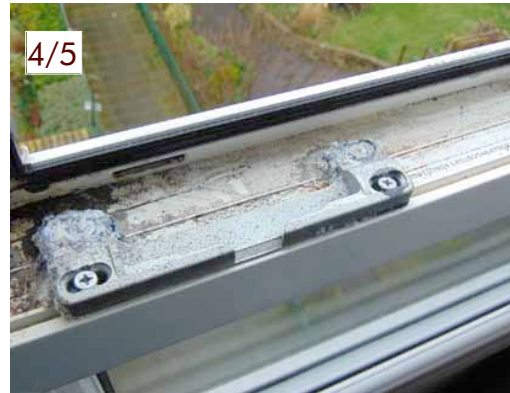
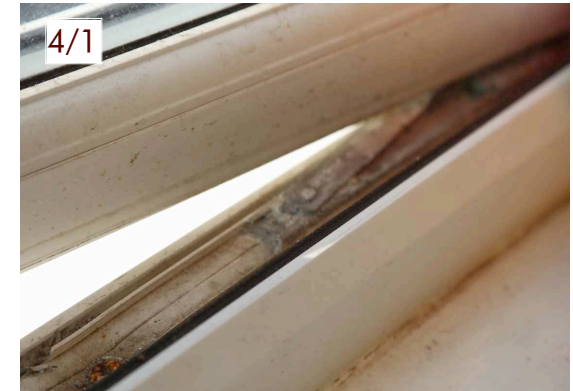
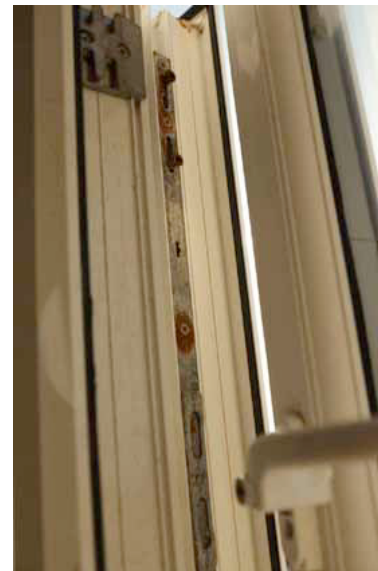
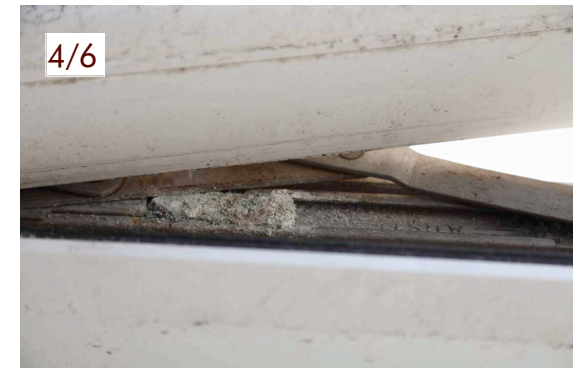
Defective ironmongery including corrosion, mortar spills etc.

4/5: corrosion and mortar spills affecting operation of lock

4/1: corrosion of stays

1/2: corrosion of sliding locking bolt.

4/6: mortar spills affecting operation of lock

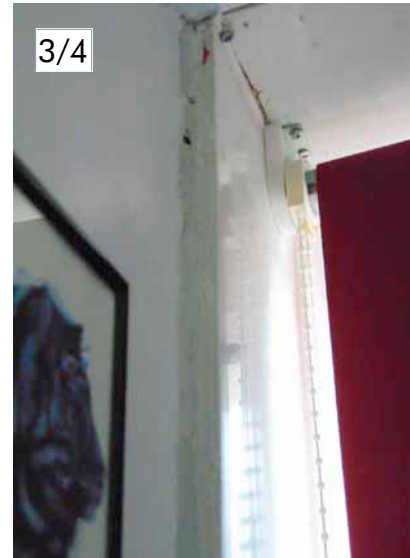
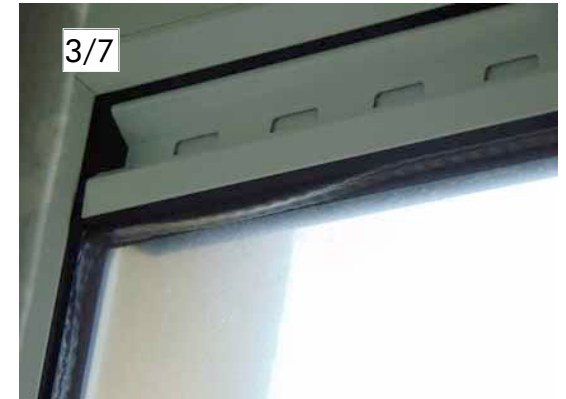
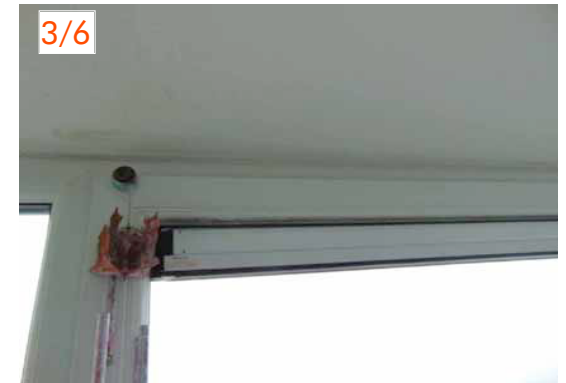
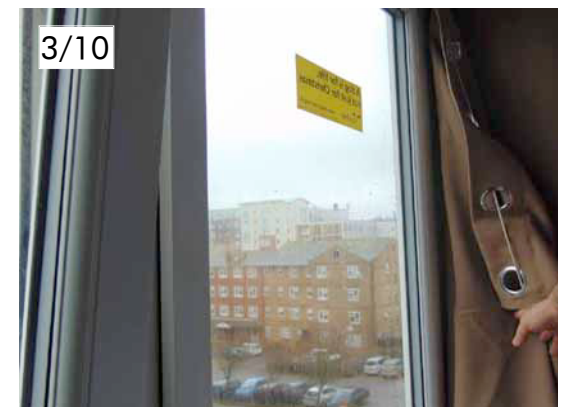
3/4: Leaking at head of window and jamb

3/7: Dislodged gasket internally

3/6: Defective installation of blind

3/7: Mortar stains on glass, labels not removed
