**Application Number:** BH2010/01518                      **Ward:** Rottingdean Coastal  
**Address:** 15 Wanderdown Close, Ovingdean  
**Proposal:** To fell 1 x Fraxinus excelsior (Ash) covered by Tree Preservation Order (No 15) 1973. (Area Order).  
**Officer:** Di Morgan, tel. 01273 292929  
**Date Received:** 19 May 2010  
**Applicant:** Mr Henry Mason

**BH2010/01518: 15 Wanderdown Close**

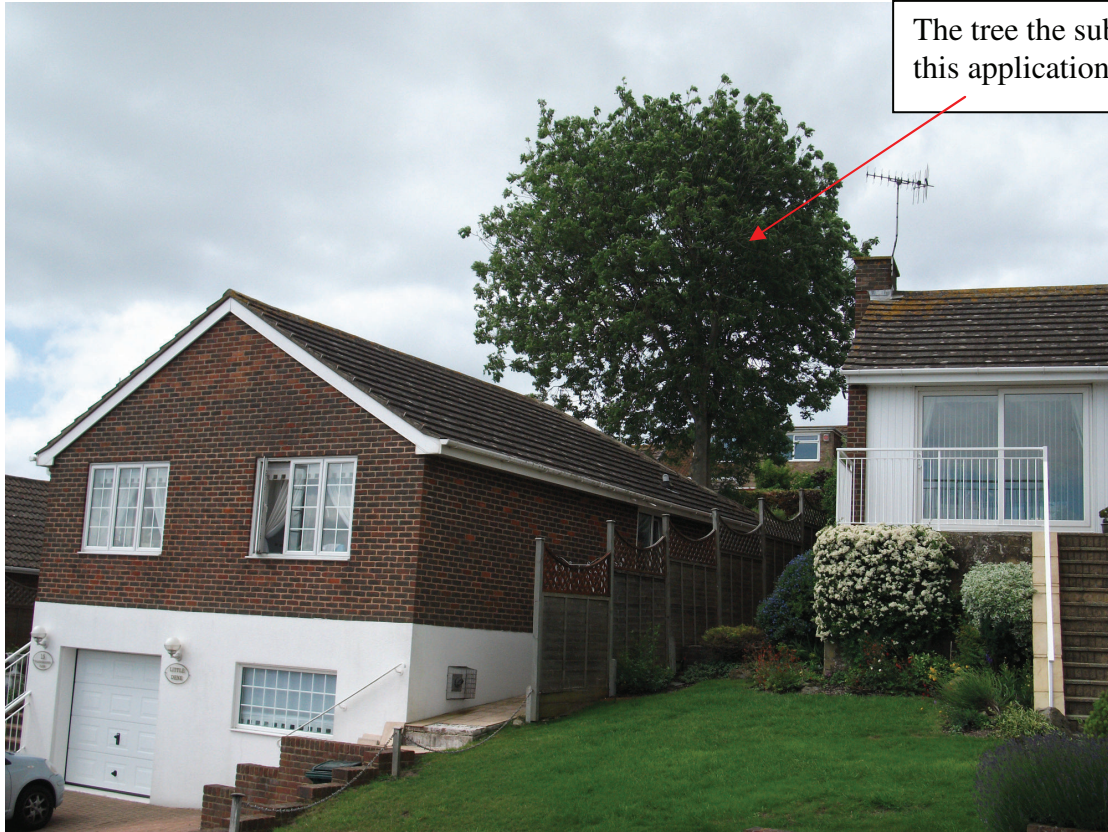
5.1 The tree the subject of this application is approximately 10 - 12 metres high with a crown spread of approximately 8 metres. The main stem of the tree divides into two at 2 metres. The tree pre-dates the property and is covered by an Area Tree Preservation Order.

The tree the subject of this application.

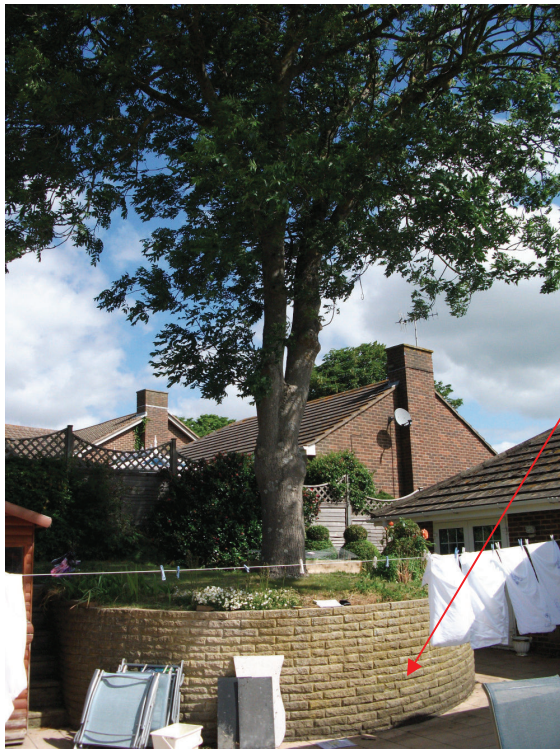
- 5.2 The planter in which the tree stands is just over 1 metre in height. The tree is towards the southern end of the planter, approximately 1.5 metres from the edge. There is approximately 2 metres to the western edge of the planter and 2 metres to the eastern edge of the planter, with a further 2 metres to the property (making the tree a distance of approximately 4 metres from the property).

Tree in approx 1m high planter in rear garden of property.

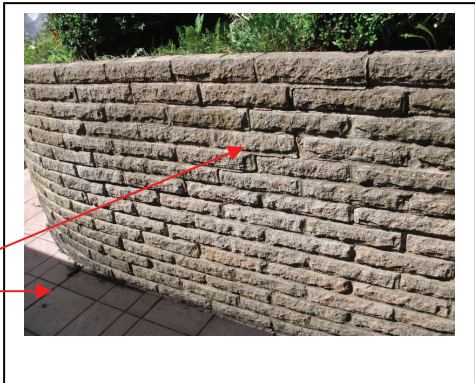
- 5.3 The planter itself is made of single-skin brick and the mortar in places has cracked but not dislodged. This may have been caused by the tree's roots. This is not the same brick as the property itself, or the boundary wall of the property. The owner of the house was present at the time of the inspecting officer's visit and said that the current brickwork of the planter was put in by them. She thought that the original brickwork was behind this, but it could not be seen.

- 5.4 Near where the wall is cracked (see para above), the patio between the planter and the house is indeed raised. The mortar between the tiles laid on the patio has not cracked and shows no sign of distress, and for this reason the inspecting officer suspects that the tree's roots have not caused this raised area. In this area, there appears to be a different inlay of bricks that appear to be the size of a drain cover, and we therefore question if this raising of the patio area has been present since the time of its construction.

Slight cracking to wall and raised patio slabs.

- 7.3 The retaining wall of the planter could be fixed and the tree remain in situ, the wall being rebuilt using engineering methods designed to absorb the impact of any root activity.
- 7.4 The canopy of the tree could be pruned to alleviate the problems being experienced regarding shading and overhang.
- 7.5 The tree is currently covered by an Area Tree Preservation Order. Should the Arboricultural Section update this Order to identify individual trees, this tree would most certainly be considered for inclusion in any new Order.
