Application Number: BH2010/01703 **Ward:** Hangleton and Knoll
Address: 20 Hangleton Manor Close
Proposal: To fell 1 x Populus nigra (Black Poplar)
covered by Tree Preservation Order (No 18) 2001
Officer: Di Morgan, tel. 01273 292929
Date Received: 10 June 2011
Applicant: Mr Vernon Hardman, 24 Hangleton Manor Close

BH2011/01703: 20 Hangleton Manor Close

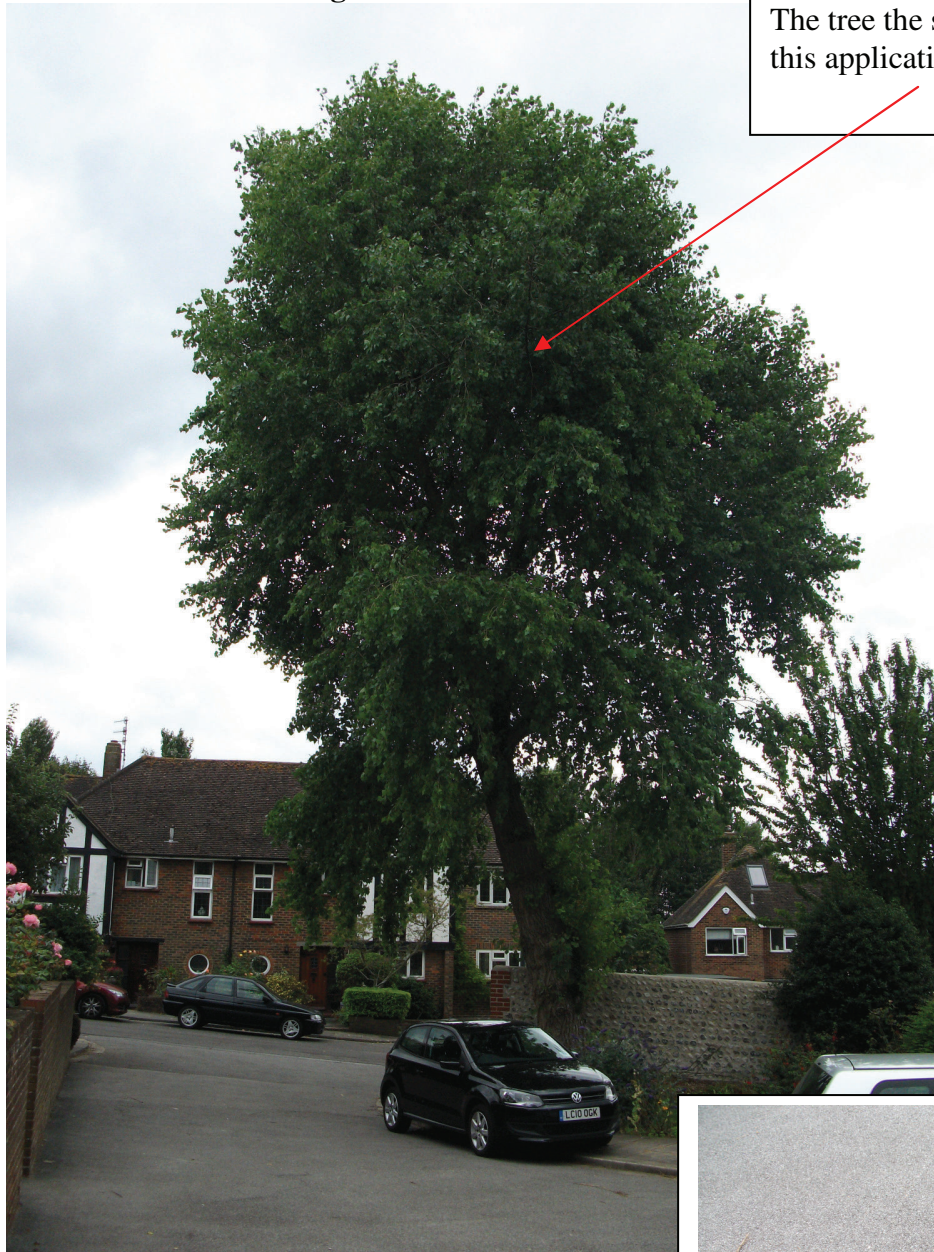
- 5.1 The over-mature tree the subject of this application is approximately 18 – 20 metres high with a full crown spread of approximately 12 – 14 metres

- 5.2 The tree is very prominent on the landscape.
- 5.3 There were no structural defects visible within the tree at the time of the inspecting officer's visit that would indicate the tree should be felled.

- 5.4 The tree is leaning in a NE direction as it has matured with the prevailing south westerly winds. The tree should put on reactionary wood to combat the effects of this wind. The 15 degree lean is not sufficient to cause alarm at this stage and there were no visible signs of the tree moving within the ground.

The tree the subject of this application.

- 5.7 The canopy of the tree is indeed full and wind loading will have an effect on the tree, however it was felt by the inspecting officer that the tree could be pruned to sufficiently reduce the risk of the tree or any of its branches failing in the short / medium term.

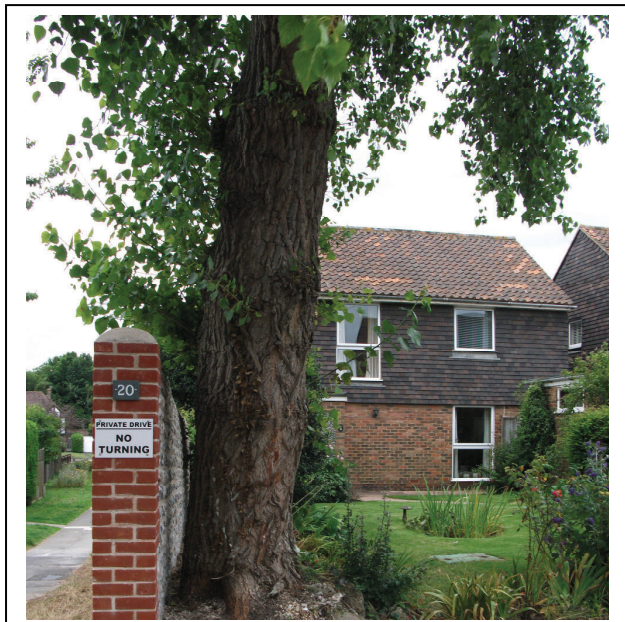
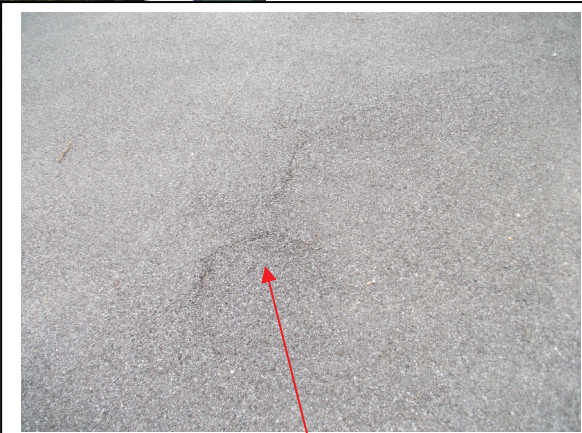
- 5.5 The flint wall has recently been repaired and the tree remains in situ.
- 5.6 The private driveway / roadway has been damaged by a tree root, and the root is likely to be from this Poplar. The damage caused appears to be minor at this time and it is presumed if the roadway is to be repaired, it could be repaired with the tree remaining in situ.

Cracked and slightly raised road surface – root activity underneath.
