**Application Number:** BH2010/03467      **Ward:** Woodingdean  
**Address:** 45 Crescent Drive North  
**Proposal:** To fell 1 x Aesculus hippocastanum (Horse Chestnut), 1 x Betula pendula (Silver Birch), 1 x Fagus sylvatica (Beech) covered by Tree Preservation Order (No. 12) 1986.  
**Officer:** Di Morgan, tel. 01273 292929  
**Date Received:** 28 October 2010  
**Applicant:** R W Green Ltd, Lewes

BH2010/03467  
45 Crescent Drive North

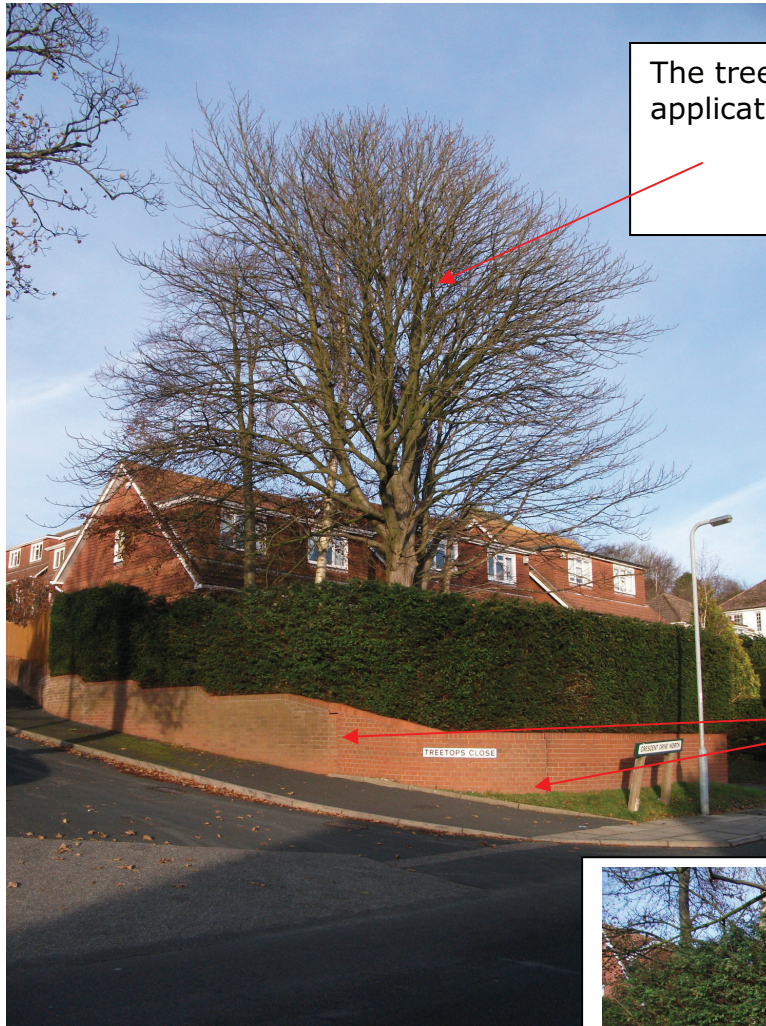
- 6.2 The Silver Birch is approximately 15 metres high with a crown spread of 8 – 9 metres. The tree is drawn up as it has grown amongst the other trees the subject of this application. The deadwood appears to be minimal at this stage and could be pruned out.

- 6.3 The Beech is approximately 13 metres high with a crown spread of 6 – 7 metres. There is a weak union at approximately 6 metres

and the tree may be closer to the property than is ideal, however, both of these issues could be overcome by regular judicial pruning.

- 6.4 None of the above trees had visible defects at the time of the inspecting officer's visit that could not be overcome by an appropriate pruning regime.
- 6.5 No loss or damage is likely to occur if the application is refused (the wall has already been damaged).

The trees the subject of this application.

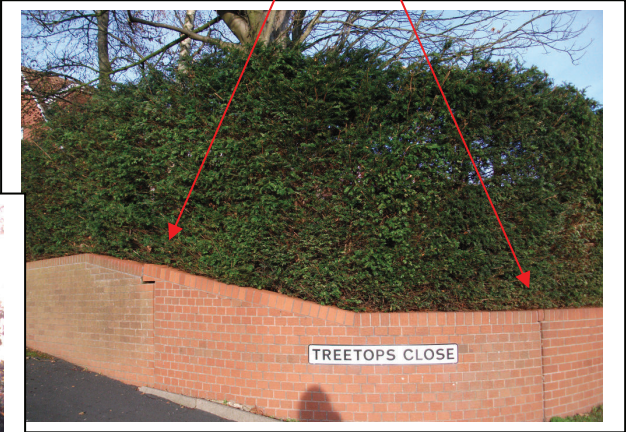
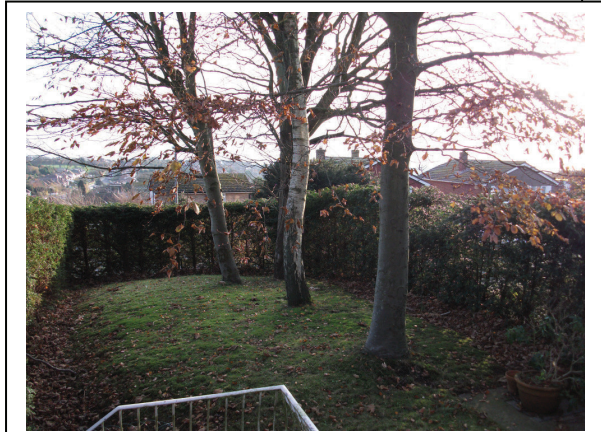
- 6.1 The Horse Chestnut is approximately 12 metres high with a crown spread of 10 – 11 metres. Horse Chestnut Leaf Miner (*Camararia orhidella*) affects the leaves of the tree and whilst it may be detrimental to the tree, it does not affect the structural stability of the tree. As stated by the applicant, there is a stem wound at 300 mm above ground level, but there would appear to be no structurally significant decay at this point. It is likely that the brick retaining wall has been damaged by the root activity of the Horse Chestnut. However, the wall will need to be repaired regardless of whether the tree stays or is felled, and therefore it was felt by the Inspecting Officer that the tree could remain in situ and the wall be rebuilt around it. Engineering solutions could be sought at the time of the rebuilding of the wall that would minimise the likelihood of future root damage.

Expanded expansion joints.
