Application Number: BH2009/01760 **Ward:** Rottingdean
Address: Hillside, The Green, Rottingdean
Proposal: To fell 1 x Sycamore (Acer pseudoplatanus)
covered by Tree Preservation Order (No 13) 2004.
Officer: Di Morgan, tel. 01273 292929
Date Received: 20 July 2009
Applicant: Mr David Boys

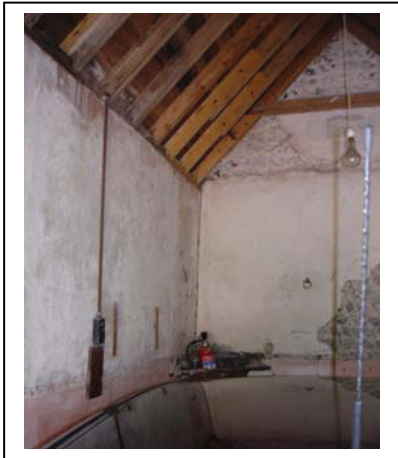
5.4 The tree sits tight in a corner behind the coach house and next to the wall. Both are flint structures. The main trunk is 15 cms from the wall, with the buttress roots against the wall. The other side of this wall is the neighbour's barn. The barn's wall is also this boundary wall and there is allegedly damage to the interior wall of the barn, although access was not possible at the time of the inspecting officer's visit. The tree is less than half a metre from the rear of the coach house. There is structural damage visible between the wall and the coach house.

5.5 Approximately 6 metres away from the tree is a barn that is in the ownership of the applicant. This barn also uses the flint boundary wall as its rear wall. There is evidence of structural damage on this wall that is likely to have been caused by the tree.

5.6 There is evidence of the joins being repaired before. The applicant has lived here for 12 years and apparently these repairs were carried out by a previous owner. The cracks are now opening again and are getting worse, although there is no supporting evidence provided.

5.7 No structural engineer's report has been submitted with the application, however, the inspecting officer is in no doubt that the tree has caused structural damage to three listed structures, with a fourth structure likely to have been damaged but not seen at the time of the site inspection.

Three pictures showing three different locations where the tree has probably caused damage to listed buildings / structures.

7.2 The structural damage will continue to worsen all the time the tree is still in situ. The close proximity of three flint buildings and one flint wall mean they have all been affected by this one tree.

7.3 The tree is not just damaging the wall, but 3 buildings that are adjoining this wall. The arboricultural section question whether the 3 buildings could be repaired and guaranteed against further damage from the tree if the tree were to remain in place.

8.3 The 4 listed structures being affected by the tree are likely to be of higher public amenity value than the sycamore, and therefore it is felt that consent should be granted to fell the sycamore and a replacement secured in a more appropriate location.
