RECORD OF DEFECTS ARISING IN MAJOR WORKS

Recorded by Leaseholders in
Brighton and Hove City Council Property

Carried out under the Term Contract with Messrs. Mears
between 2010 and 2020

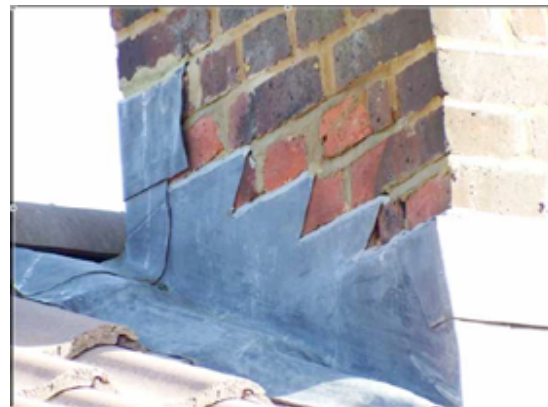
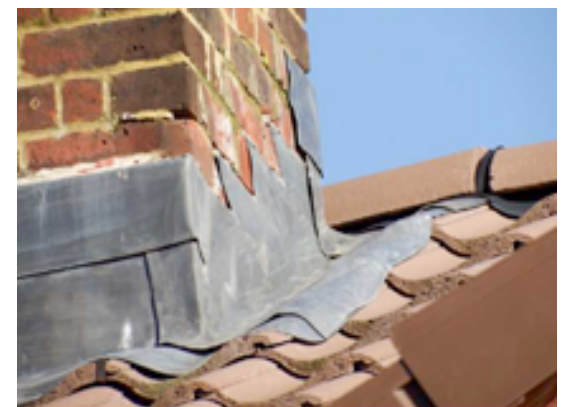
- leak on the chimney stack still outstanding - water coming through onto lounge ceiling, a faint watermark along a joint line 40cm from the chimney face and evidence of water on the back of the plasterboard

- insufficient flashing on chimney, gaping lead flashings and some old and missing pointing (pictures attached)
- the north chimney flashing is now leaking on three sides.

Top: leaking affecting adjacent ceiling as evident in roof void
Centre: general external view of chimney
Bottom: details of flashing
