RECORD OF DEFECTS ARISING IN MAJOR WORKS

Recorded by Leaseholders in  
Brighton and Hove City Council Property

Carried out under the Term Contract with Messrs. Mears  
between 2010 and 2020

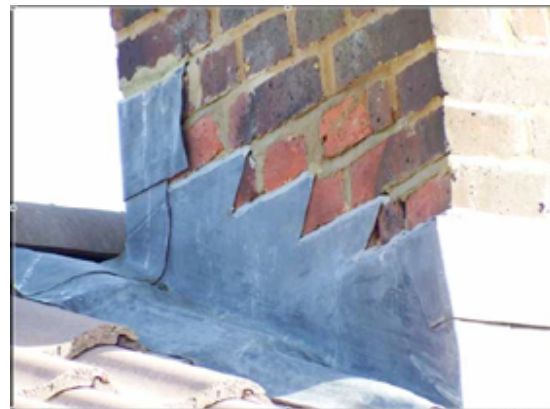
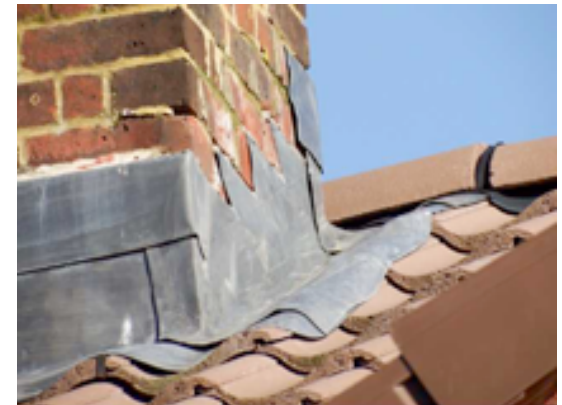
- leak on the chimney stack still outstanding - water coming through onto lounge ceiling, a faint watermark along a joint line 40cm from the chimney face and evidence of water on the back of the plasterboard

- insufficient flashing on chimney, gaping lead flashings and some old and missing pointing (pictures attached)
- the north chimney flashing is now leaking on three sides.

Top: leaking affecting adjacent ceiling as evident in roof void  
Centre: general external view of chimney  
Bottom: details of flashing
